Town of Arlington

FINAL REPORT

ADA Self-Evaluation (as basis for Transition Plan)

Prepared by
Institute for Human Centered Design
December 15, 2014

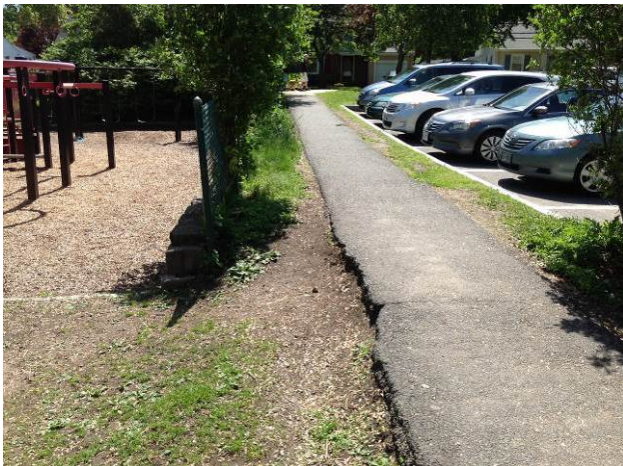
Photo 5

Additionally, the stairway leading to the baseball/little league and soccer fields does not have compliant surfaces and railings. Further, this inaccessible point of entry does not offer an ADA-compliant sign directing the public to the accessible point of entry 150 feet away. (Photo 6)

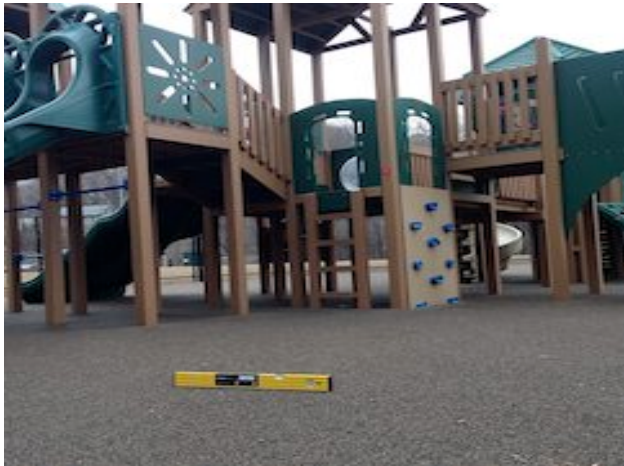
Photo 10

At the large play component area, the unitary ground surface does not have consistent levels and there are excessive cross slopes between and at the entry and exit points of accessible play components. (Photos 9, 10)

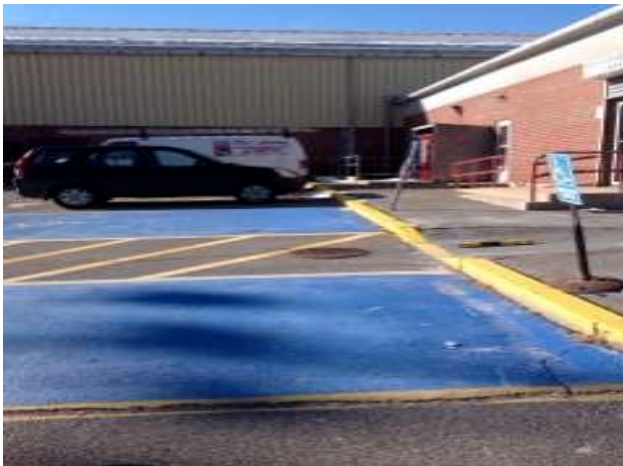
Photo 5

The two curb cuts located within the parking lot connecting the designated accessible parking spaces to facility perimeter sidewalk are located at the shared access aisles between two designated parking spaces. These curb cuts, similar to the curb cut facing Summer Street Park, have no usable features. Water and ice accumulation are probable. When crossing these curb ramps to move along the sidewalk between the Recreation Department Office on the side to the front Arena entrance doors, individuals are faced with extreme dips and rises in the sidewalk. These inaccessible curb ramps require redesign and reconstruction to come up to code. (Photo 5)

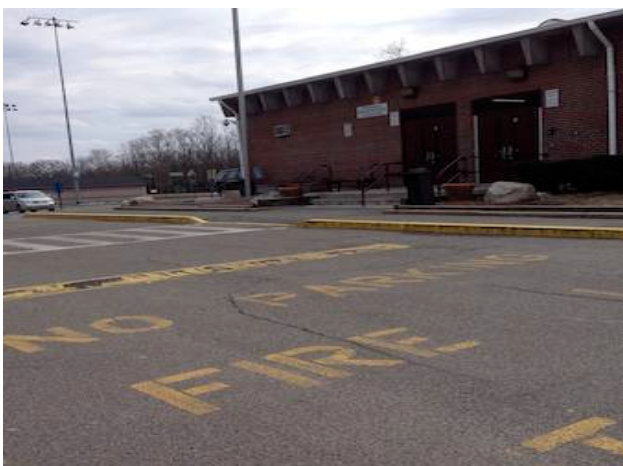
Photo 6

The facility is surrounded on three sides with a walkway that does not provide accessible connections to the parking lot crosswalks, the entrance doors, the Arena emergency exit doors, or the ramp that leads into the Recreation Department office. This inaccessible sidewalk has warped, uneven surfaces and requires redesign and reconstruction to come up to code. (Photo 6)

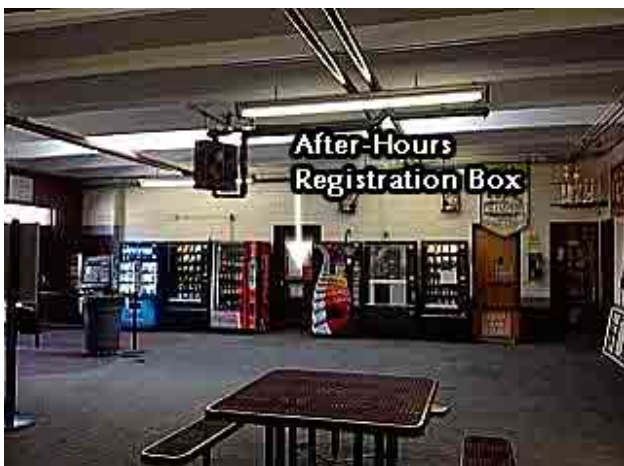
Photo 18

The Recreation Office After-Hours Drop-Off box located on the Department door between the 4th and 5th vending machines is not accessible because it is within a shallow recessed area that does not provide for unobstructed clear floor space for forward or parallel approach. (Photo 18)

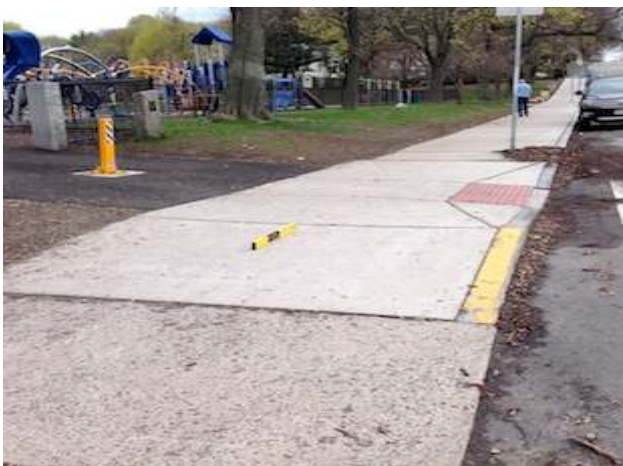
Photo 3

Eastern end of new sidewalk does not blend to compliant slopes where it meets the sidewalk pedestrian zone in front of the school drive-in area (now used for a Four-Square court). (Photo 3)

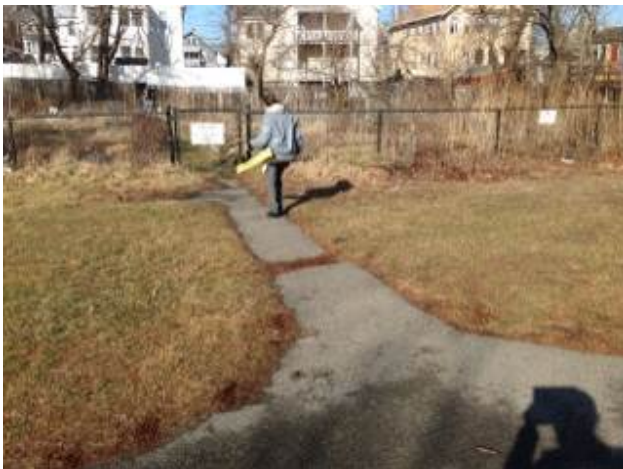
Photo 12

A gated community garden is provided near the point of entry at Herbert Road. Although the asphalt walkway connects this amenity to the rest of the facility, no accessible route or features, including an accessible gate, are offered within the garden. (Photo 12)

Completely re-configure the community garden so that accessible routes as well as planter beds at an accessible height and other features are provided within the garden.

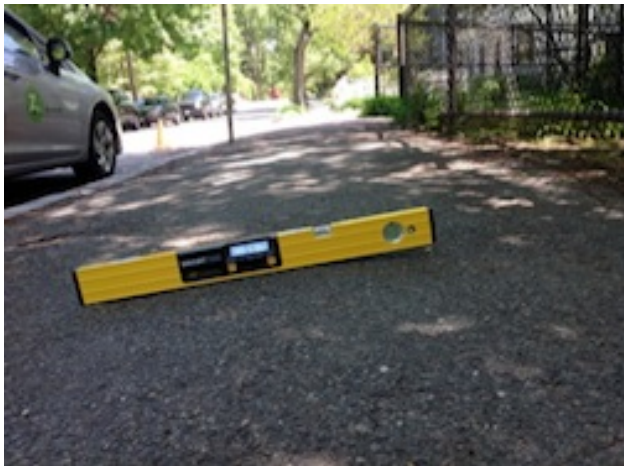
Photo 5

Sidewalks along Academy Street do not have topological constraints and need to be mitigated to provide accessible walkway slopes. The cross slopes near the Academy St. gate exceed 8% in places, where the maximum should not be more than 2.08%. (Photo 5)

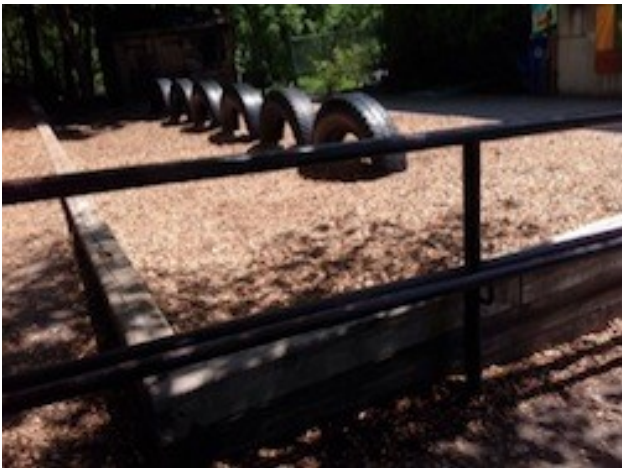
Photo 14

Although an effort was made to provide a level entry into the play area with the row of tires, the loose fill materials settle and the level entrance is not available. There can be a ramp or rubber entry provided from the surrounding walkway and an intersecting rubber tile route leading to and providing unrestricted circulation around the row of tires to provide interactive accessible play.

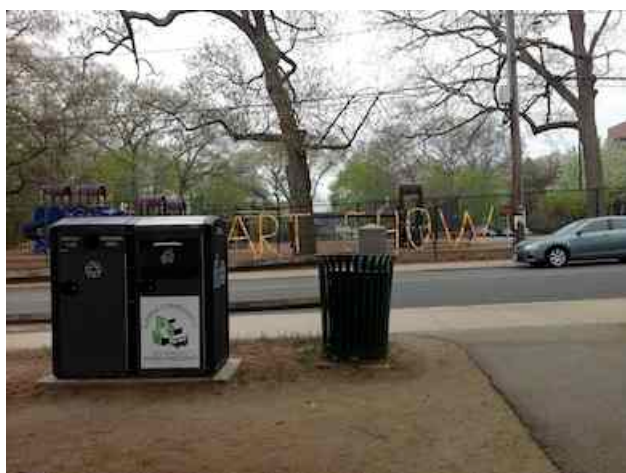
Photo 22

The recycling compactor is not located along an accessible route and is located on a platform, which does not provide accessible reach ranges or accessible clear space for forward and parallel approach. (Photo 22)
